CONFIDENTIAL INSPECTION REPORT

Commercial Building Inspection

XXXX MIDDLE TN DRIVE

Inspection Date: XX / XX / XXX

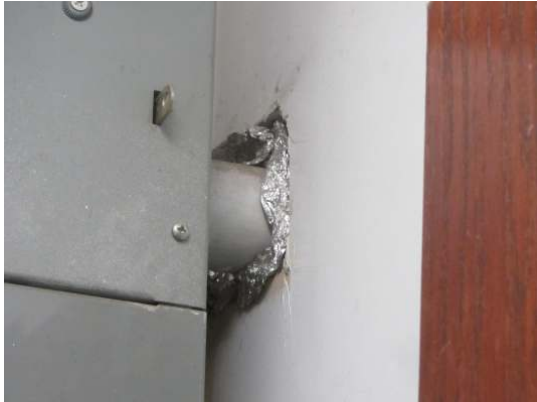
Suggest properly sealing air gaps at Main power to avoid rodent risk

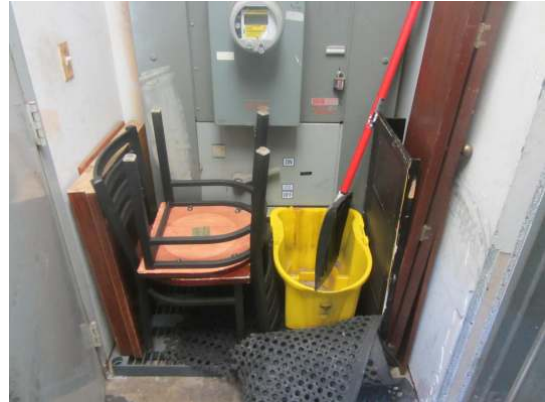
Suggest maintaining proper clearance to power main.

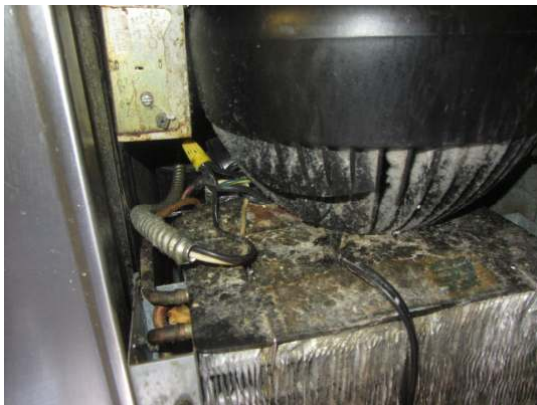
Exposed high voltage wiring at line Cooling compressor

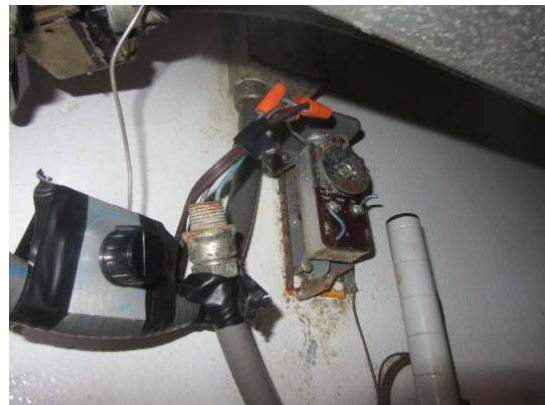
Exposed electrical within walk-in at compressor

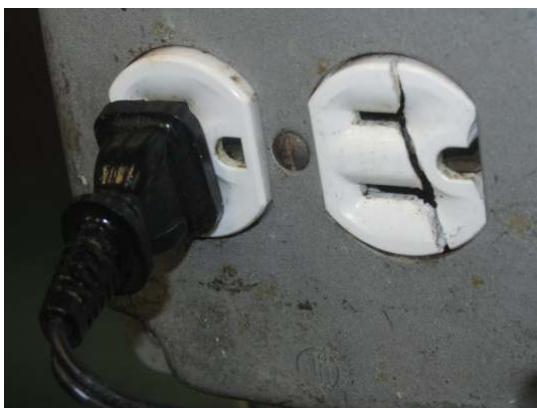
Damaged outlet at walk-in exterior Wall/prep counter

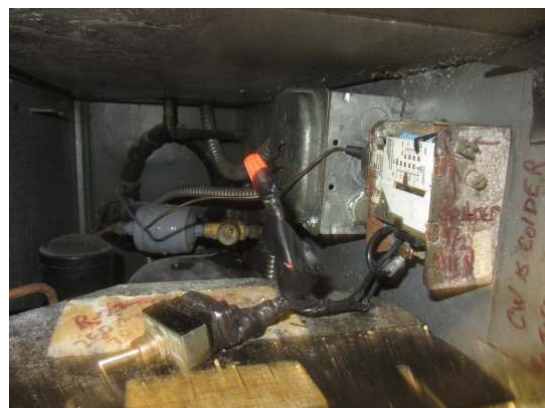
Exposed switch wiring at line cooling

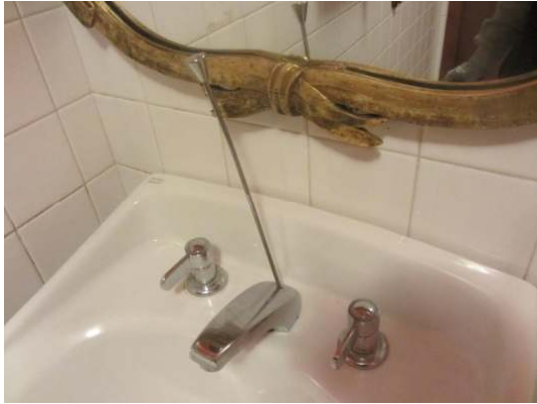
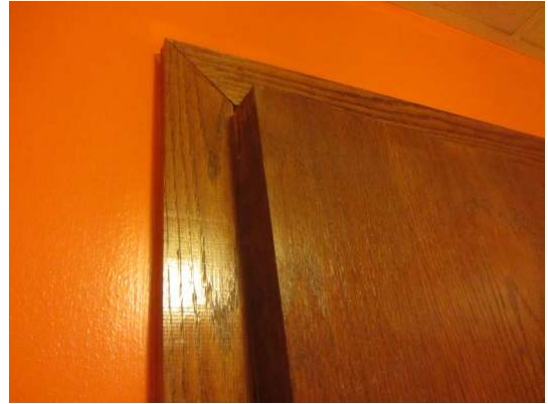
Ladies room drain stop not functional and entry door out of alignment

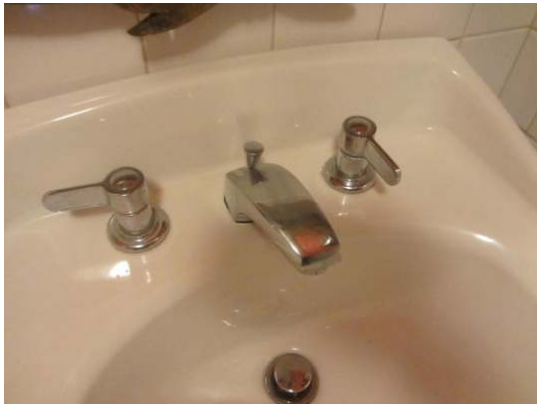
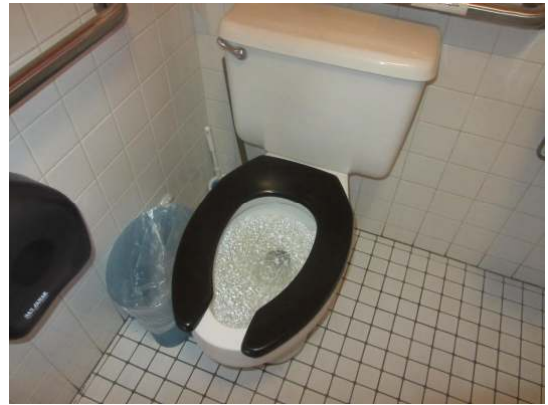
Mens room faucet handles improperly fixed and toilet continues to run water

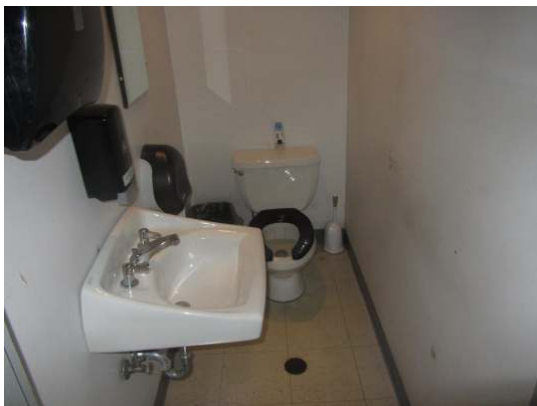
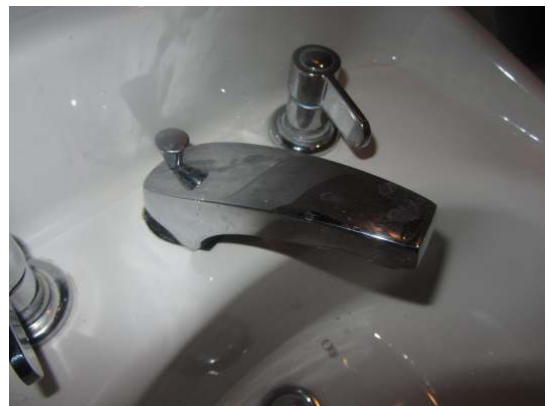
Kitchen restroom sink loose at the wall and faucet handles improperly fixed

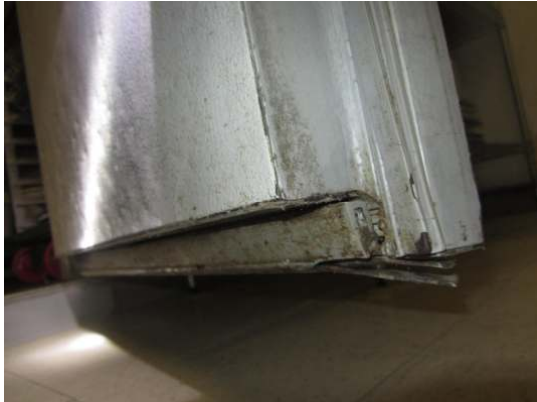
Main walk-in door seal slightly torn

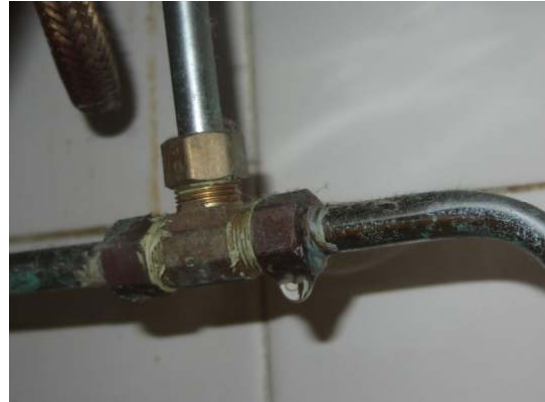
Minor water leak at hand sink in kitchen

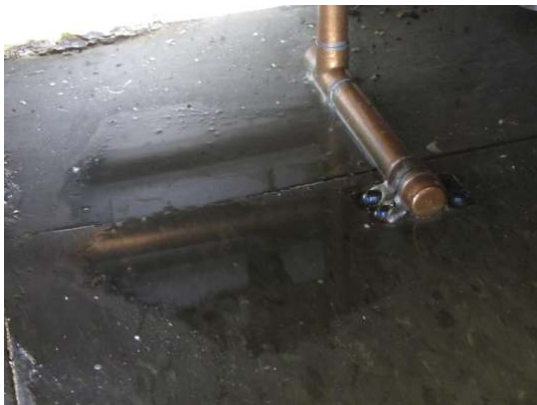
Standing water under line and dishwasher

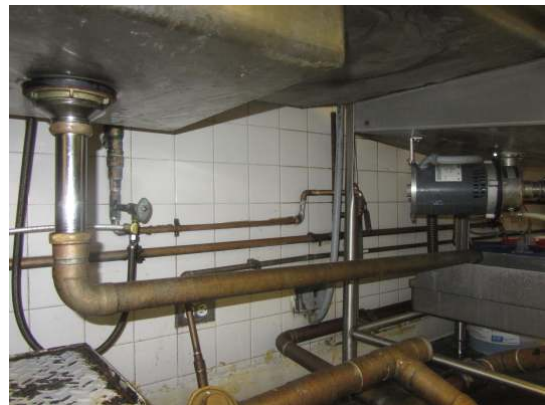
Loose drain pipe at dishwasher

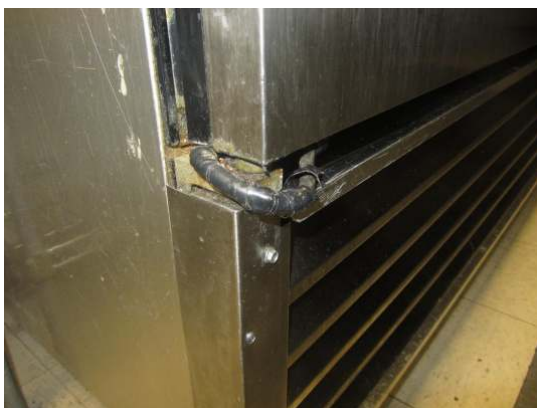
Wall freezer wiring field repair noted

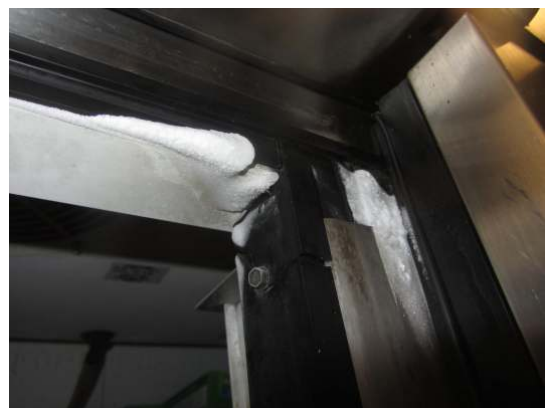
Frost/seal break at wall freezer doors

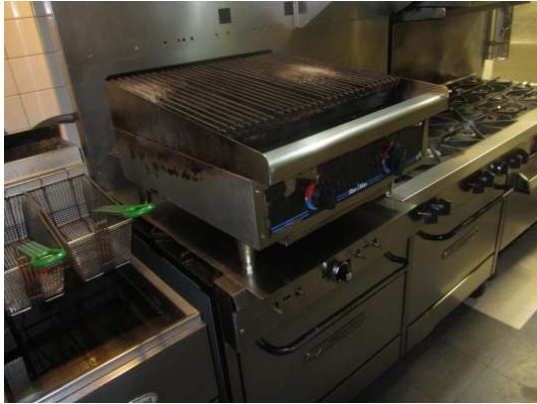
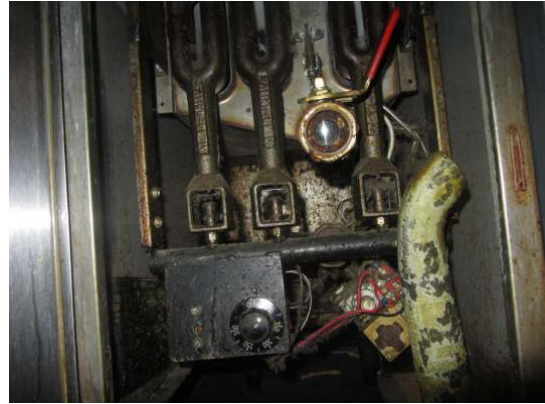
Portion of range burners not function. Fryer internals, suggest service and general maintenance on kitchen equipment due to age

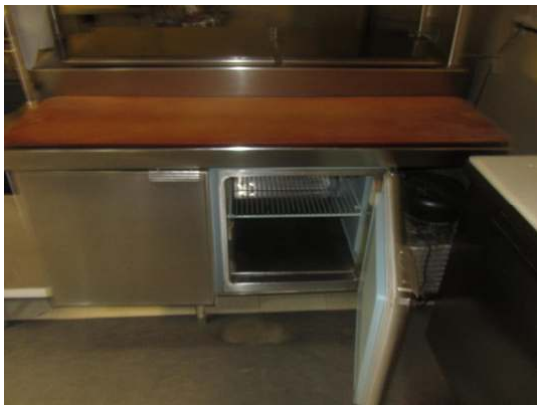
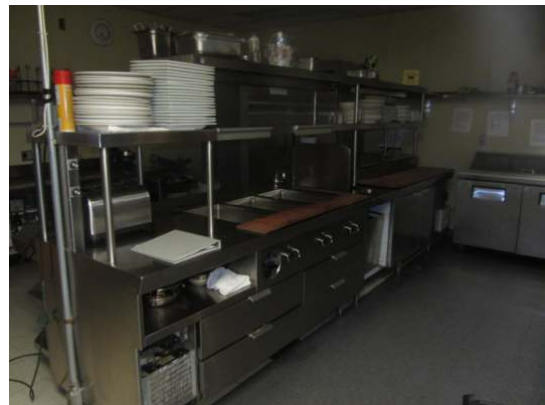
Cooling drawers under line not functional at the time of the inspection

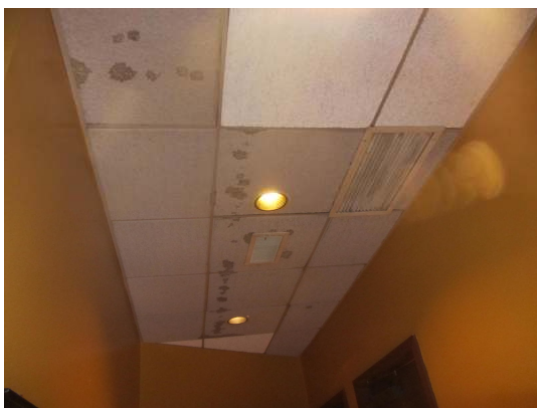
Past ceiling stains in hall, source in unknown

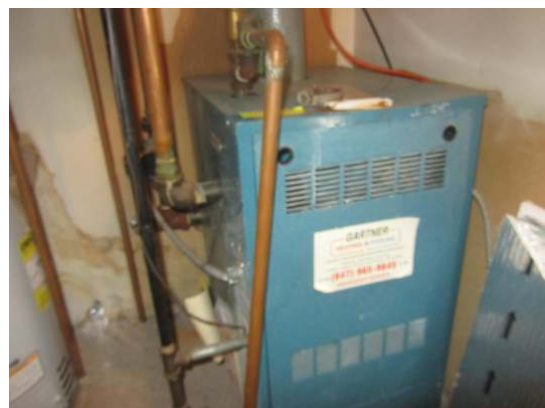
Boiler in closet is past typical life of 20-25 years 1989 MFD .

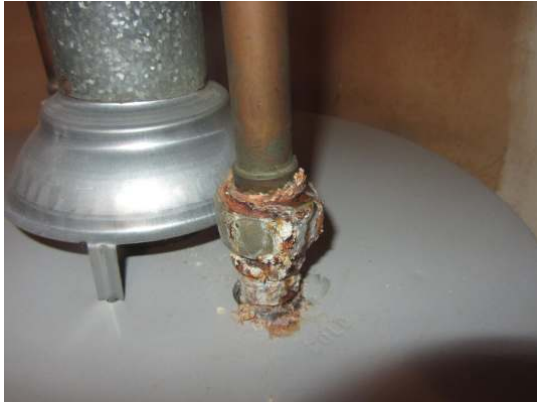
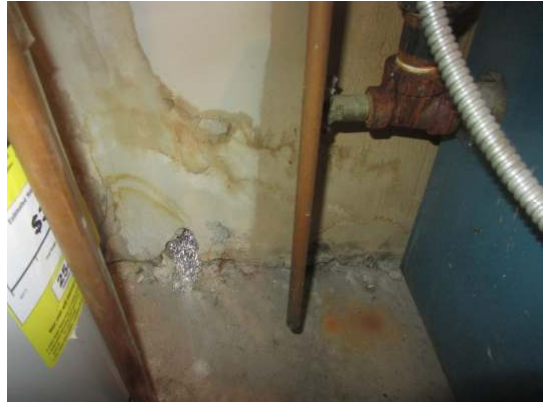
Active water leak at water heater union with water damaged walls noted

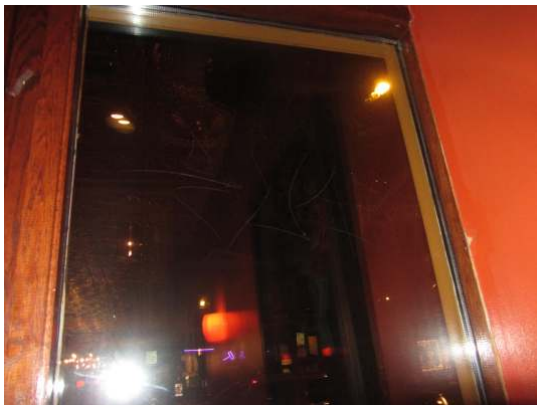
Storefront window scratched/graffiti

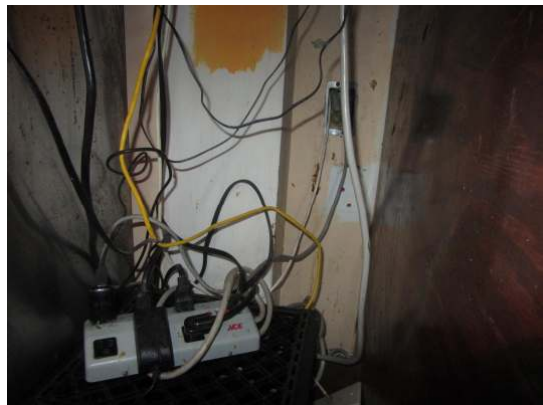
**Suggest dedicated power pr appliances
At bar / till area**
